Manhole Inspection Summary

Manhole # S21AA_046MH

Insp Date: **10/26/07 10:40 AM**

Location Address: **1915 LAFEYETTE-ALLEY-LANVALE** Cross Street: **APPLETON ST**

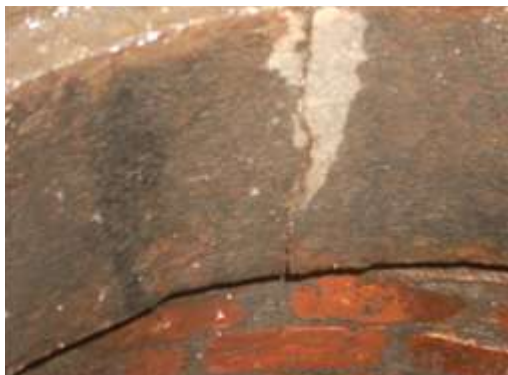
Defect 3

Frame Offset: **1** (in.) Condition: ☐ Sound ☒ **Cracked** ☐ Leaks

CRACKED FRAME

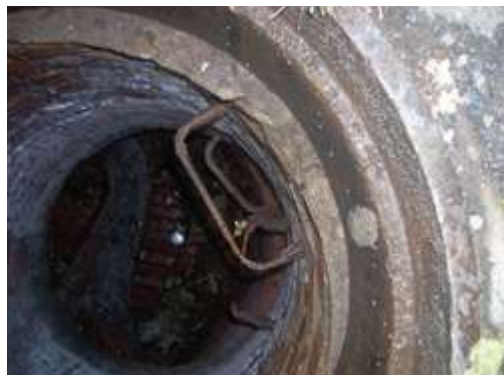
Defect 2

Steps Count: **4** Missing: **1** ☒ **Corroded**

MISSING AND CORRODED STEPS

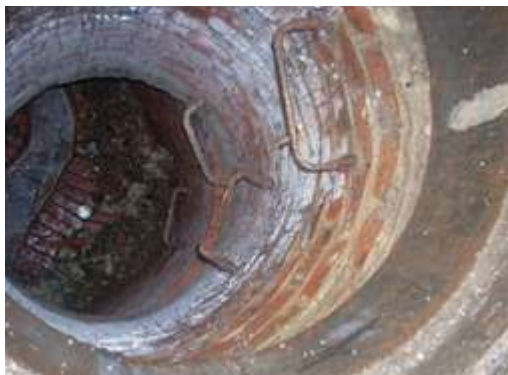
Defect 1

FRAME OFFSET

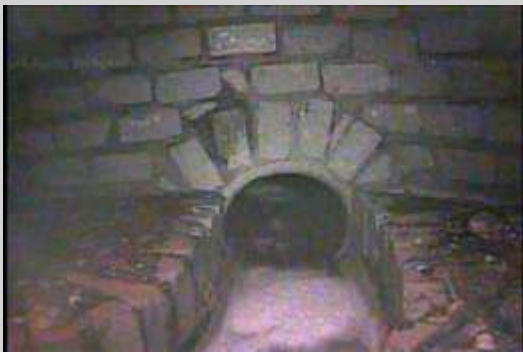
12 O'Clock Outflow

Pipe Height: **8.4** (in.) Rod and Bar (Angled)
Pipe Material: **Clay** ☐ Pipe Lined
Invert Depth: **9.42** (ft.) Flow Characteristics: **Slow**
Deposits: ☒ None ☐ Mud ☐ Sludge ☐ Debris ☐ Grease
Silt Depth: (in.) Deposits Extent:
Infiltration: **None** Pipe Seal Cond: **Sound**

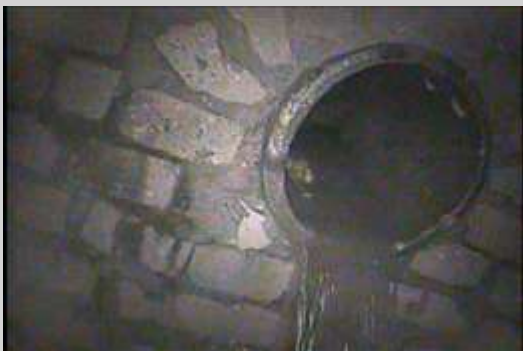
6 O'Clock Inflow

MISSING AND CORRODED STEPS

Pipe Height: **8.4** (in.) Rod and Bar (Angled)
Pipe Material: **Clay** ☐ Pipe Lined
Invert Depth: **7.74** (ft.) Flow Characteristics: **Slow**
Deposits: ☒ None ☐ Mud ☐ Sludge ☐ Debris ☐ Grease
Silt Depth: (in.) Deposits Extent:
Infiltration: **None** Pipe Seal Cond: **Sound**

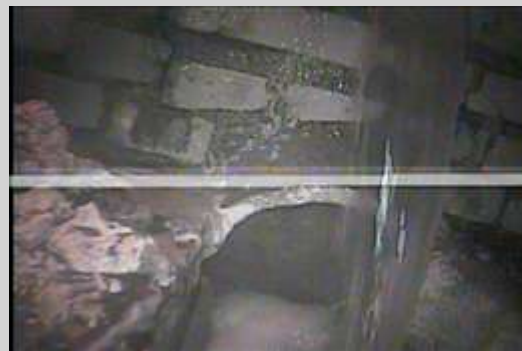
Drop In @ 6 O'Clock

MISSING AND CORRODED STEPS

Drop: **Outside** Rod and Bar
Angled: **Yes** Reading: **8.15** (ft.)
Inv Depth: **9.15** (ft.)
Drop Condition: **Clogged**

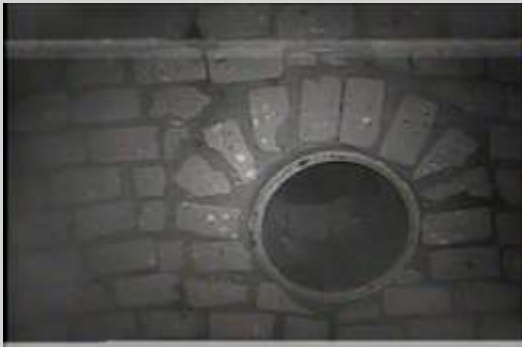
Pipe In @ 9 O'Clock

MISSING AND CORRODED STEPS

Infiltration: **None** Pipe Seal Cond: **Broken**

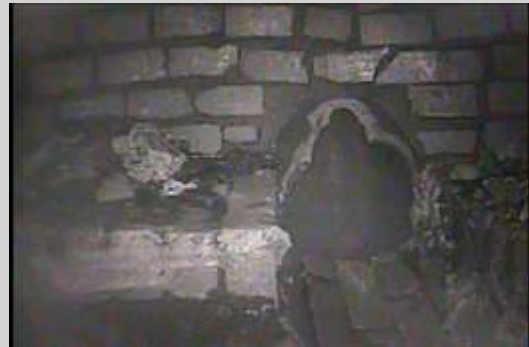
Drop In @ 9 O'Clock

MISSING AND CORRODED STEPS

Drop Condition: **Open**
